# Isothermal Fatigue, Damage Accumulation, and Life Prediction of a Woven PMC

Andrew L. Gyekenyesi  
Cleveland State University, Cleveland, Ohio

Prepared under Grant NAS3-1543

This dissertation focuses on the characterization of the fully reversed fatigue behavior exhibited by a carbon fiber/polyimide resin, woven laminate at room and elevated temperatures. Nondestructive video edge view microscopy and destructive sectioning techniques were used to study the microscopic damage mechanisms that evolved. The elastic stiffness was monitored and recorded throughout the fatigue life of the coupon and later utilized as a damage variable for a phenomenological model. In addition, residual compressive strength tests were conducted on fatigue coupons with various degrees of damage as quantified by stiffness reduction. Experimental results indicated that the monotonic tensile properties were only minimally influenced by temperature, while the monotonic compressive and fully reversed fatigue properties displayed noticeable reductions due to the elevated temperature. The stiffness degradation, as a function of cycles, consisted of three stages; a short-lived high degradation period, a consta

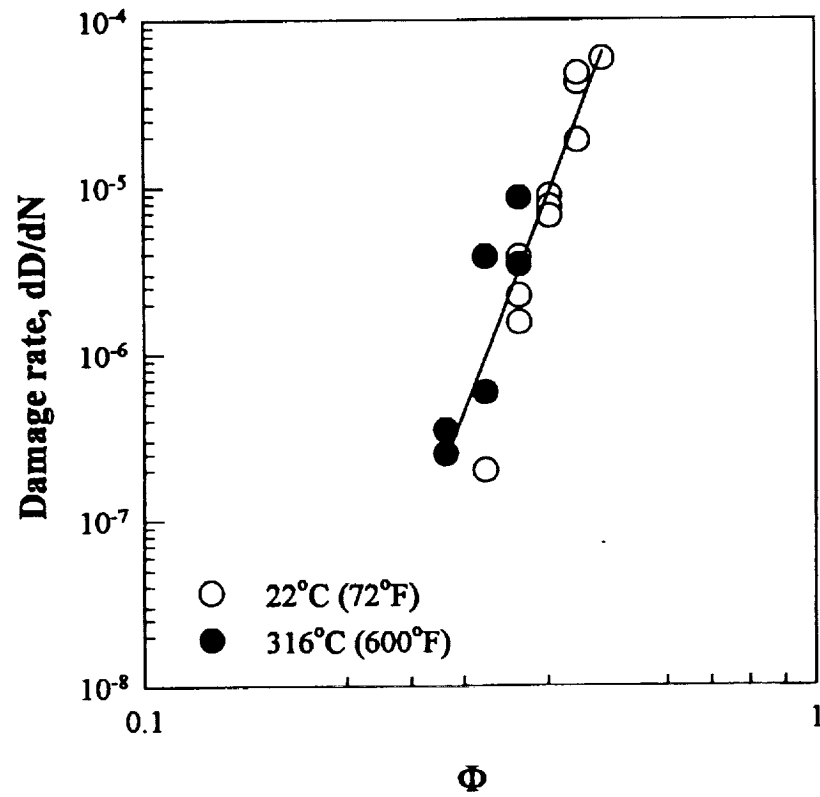
**Figure 4.3** Damage rate as a function of stress state,  $\Phi$ .

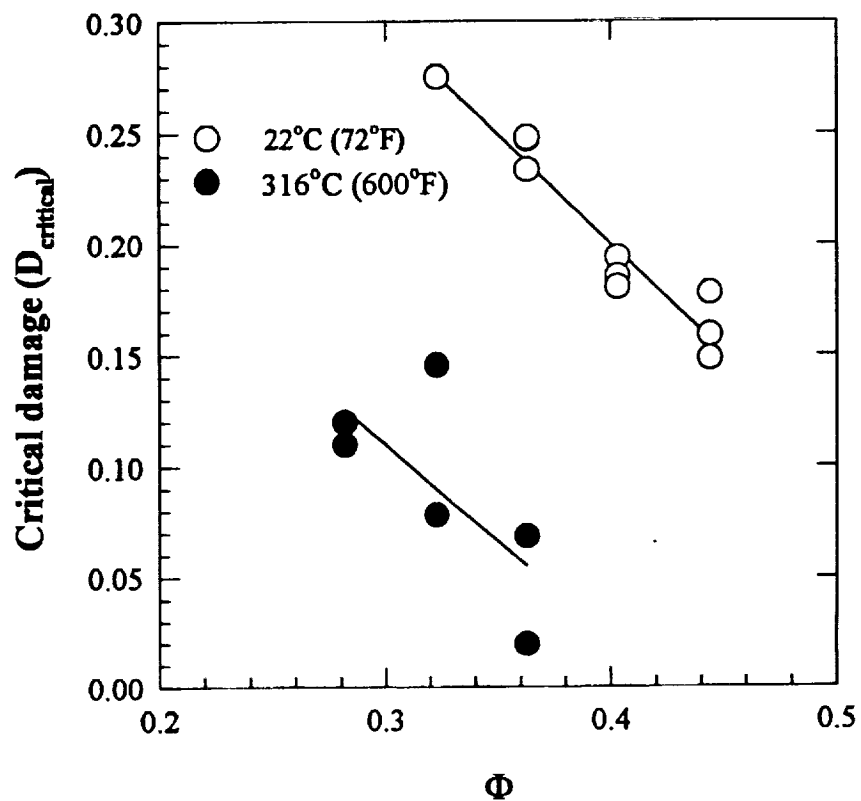
**Figure 4.4** Critical damage as a function of stress state,  $\Phi$ , and temperature,  $T$ .

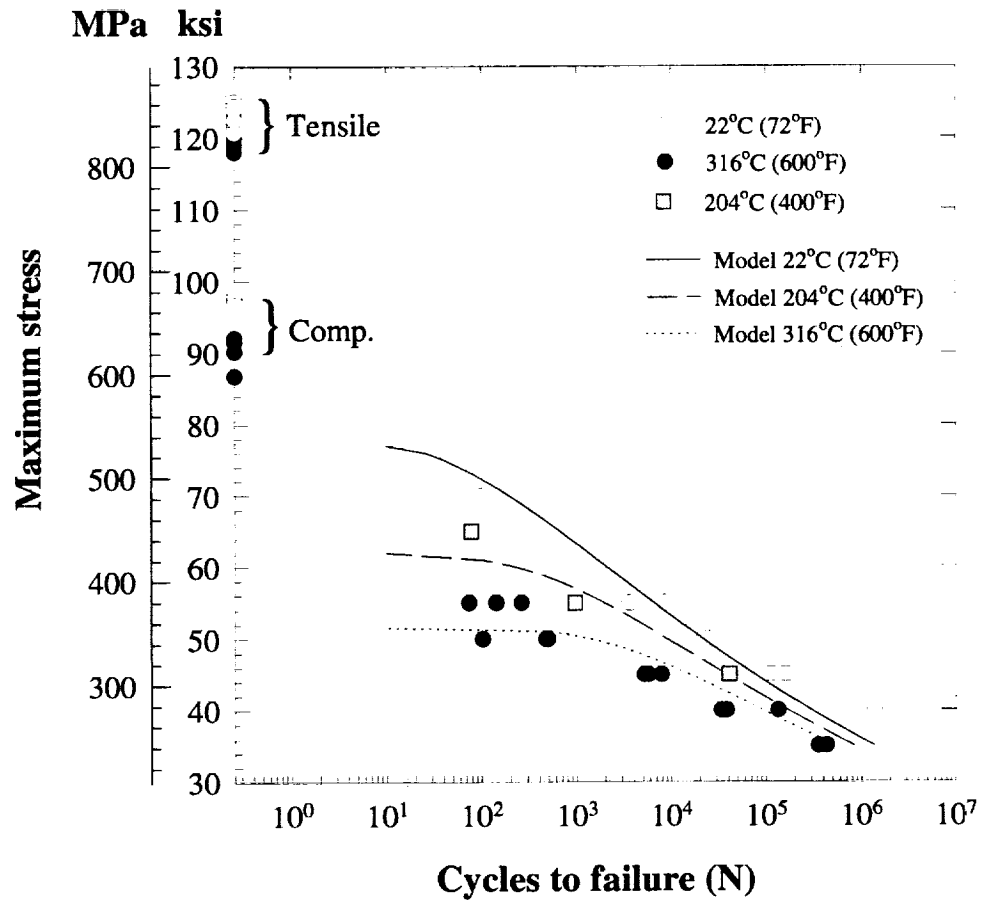
**Figure 4.5** Stress based isothermal fatigue life comparison between experimental data and analytical predictions.

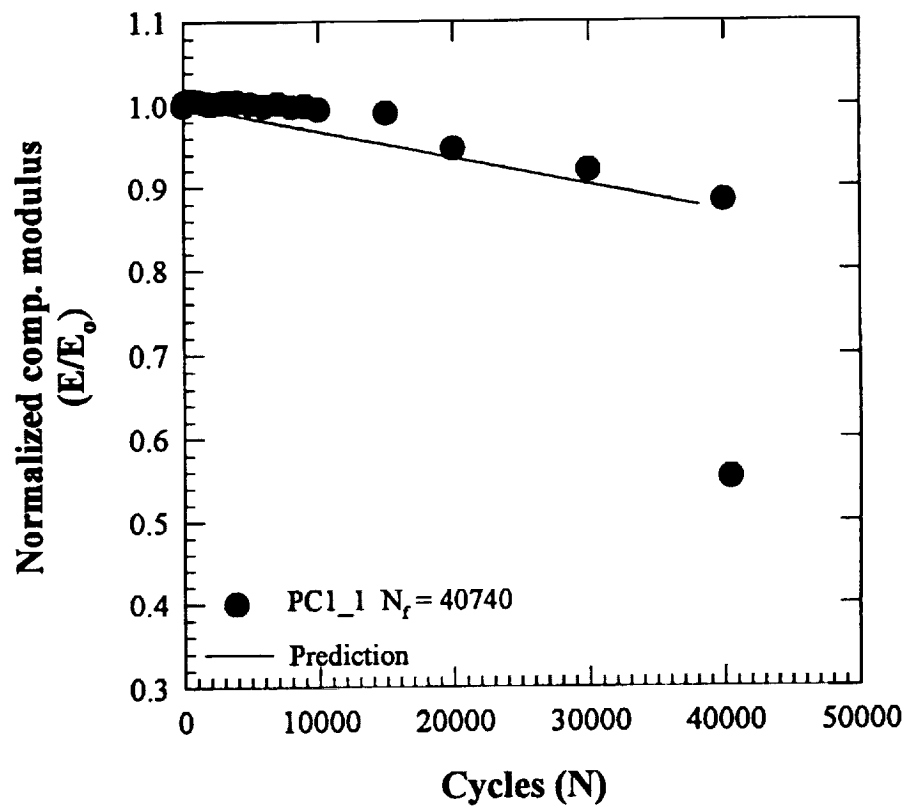
**Figure 4.6** Model versus data comparison of normalized compressive modulus as a function of cycles at 204°C (400°F):  $\sigma_{Lmax} = 310$  MPa (45 ksi);  $\Phi = 0.363$ .
